LONG-TERM STORABILITY OF PROPELLANT TANKAGE AND COMPONENTS

TECHNICAL REPORT AFRPL-TR-69-82

APRIL 1969

**AIR FORCE ROCKET PROPULSION LABORATORY
DIRECTORATE OF LABORATORIES
AIR FORCE SYSTEMS COMMAND
UNITED STATES AIR FORCE
EDWARDS, CALIFORNIA**

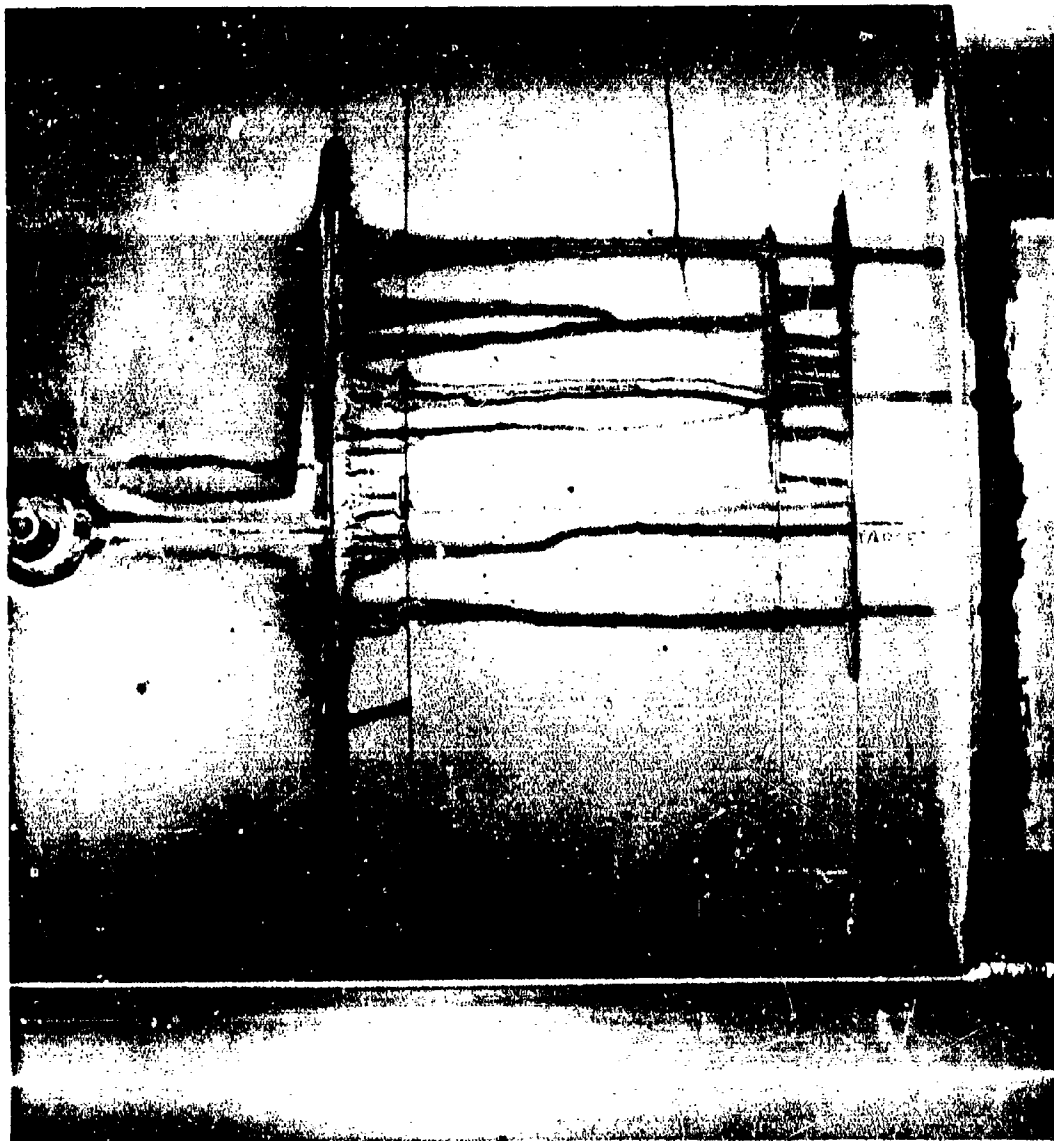
Figure 1. Hydroscopic Action of NO₂ Vapor

Experience with liquid propellant rocket feed systems has shown that leakage of oxidizers can occur and constitute a difficult problem under certain environmental conditions. In propellant tankage, leakage has been observed in or adjacent to weldments, and more specifically in weldments in which a double heat cycle has occurred, either by repeated welding to effect a repair or by intersecting weldments. It has been shown experimentally (1) in the case of N_2O_4 , that when a vapor leak occurs the result is drastically influenced by the relative humidity of the atmosphere surrounding the tanks. If the relative humidity is on the order of 30 percent or lower, the nitric oxide vapor, which is the leaking fluid, dissipates into the atmosphere and does nothing to aggravate the leakage. If the relative humidity is in the order of 40 percent or greater, however, it does not dissipate, but rather hydrolyzes, forming dilute nitric acid on the exterior surface in the immediate vicinity of the leak (Figure 1). The action of the nitric acid is to enlarge the original leakage path, working inward toward the source of the leak. Eventually, a small, or even minute vapor leak can become a large liquid leak, if it is allowed to proceed. Although a similar detailed experimental program has not been performed with the storable fluorinated oxidizers such as ClF_3 and ClF_5 , an analagous process would be expected with hydrogen fluoride as the hydrolysis product.

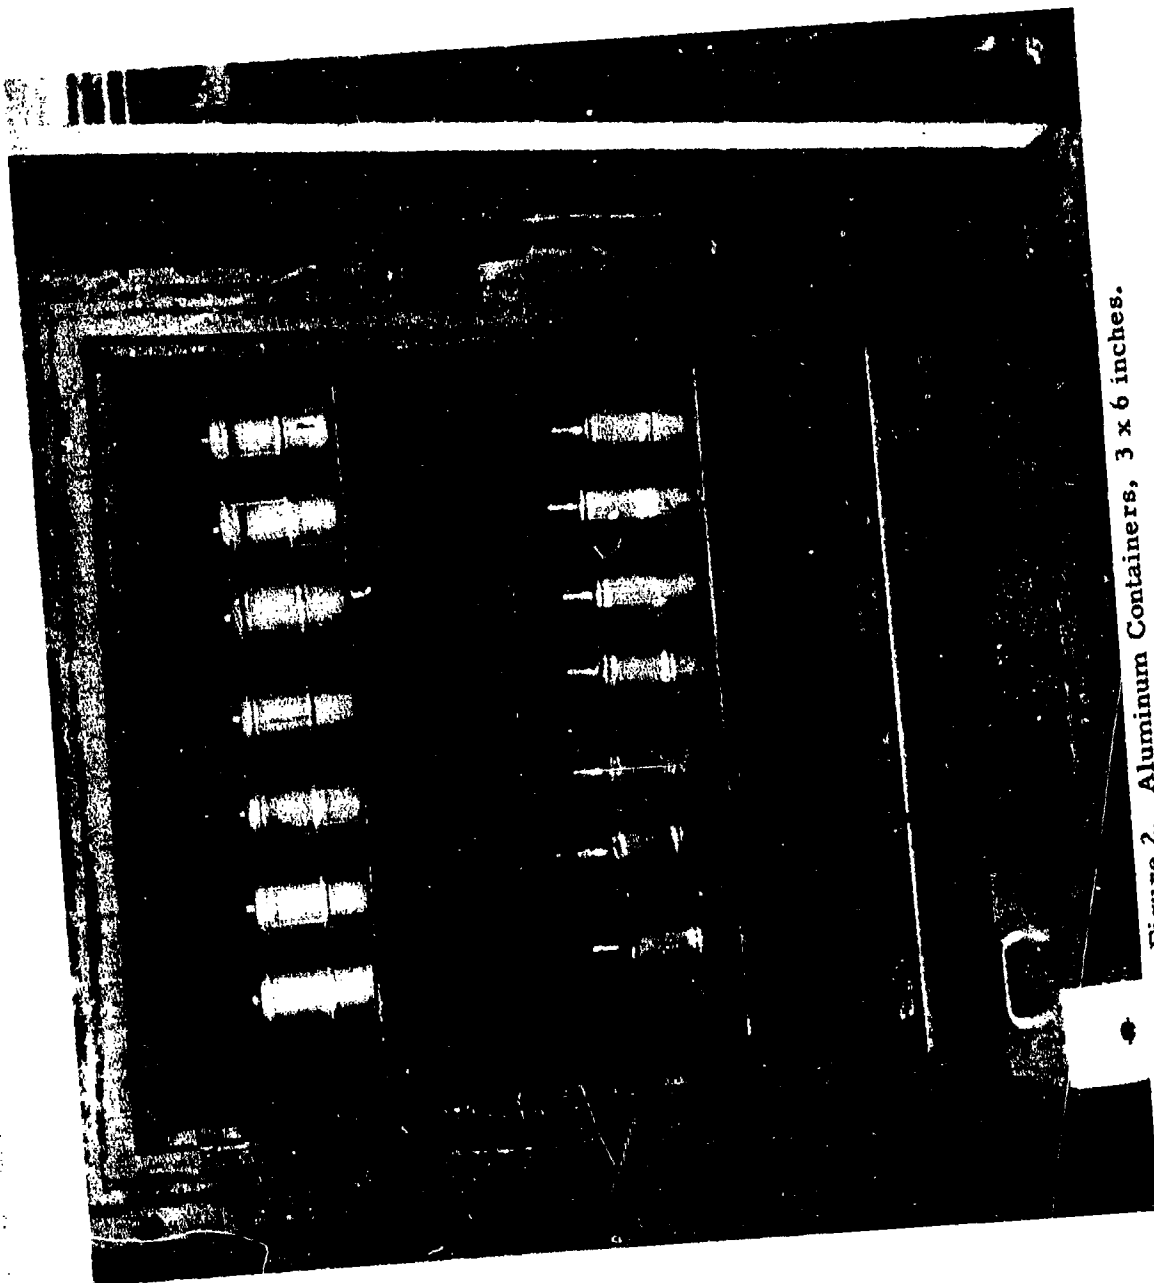
Figure 2. Aluminum Containers, 3 x 6 inches.

Part 1 - 3- by 6-inch Containers. Forty containers manufactured from 2014 T-6 aluminum, by Douglas, General Dynamics, Martin, and North American are used to evaluate various approaches to manufacturing 2014 T-6 tankage for containment of N_2O_4 .

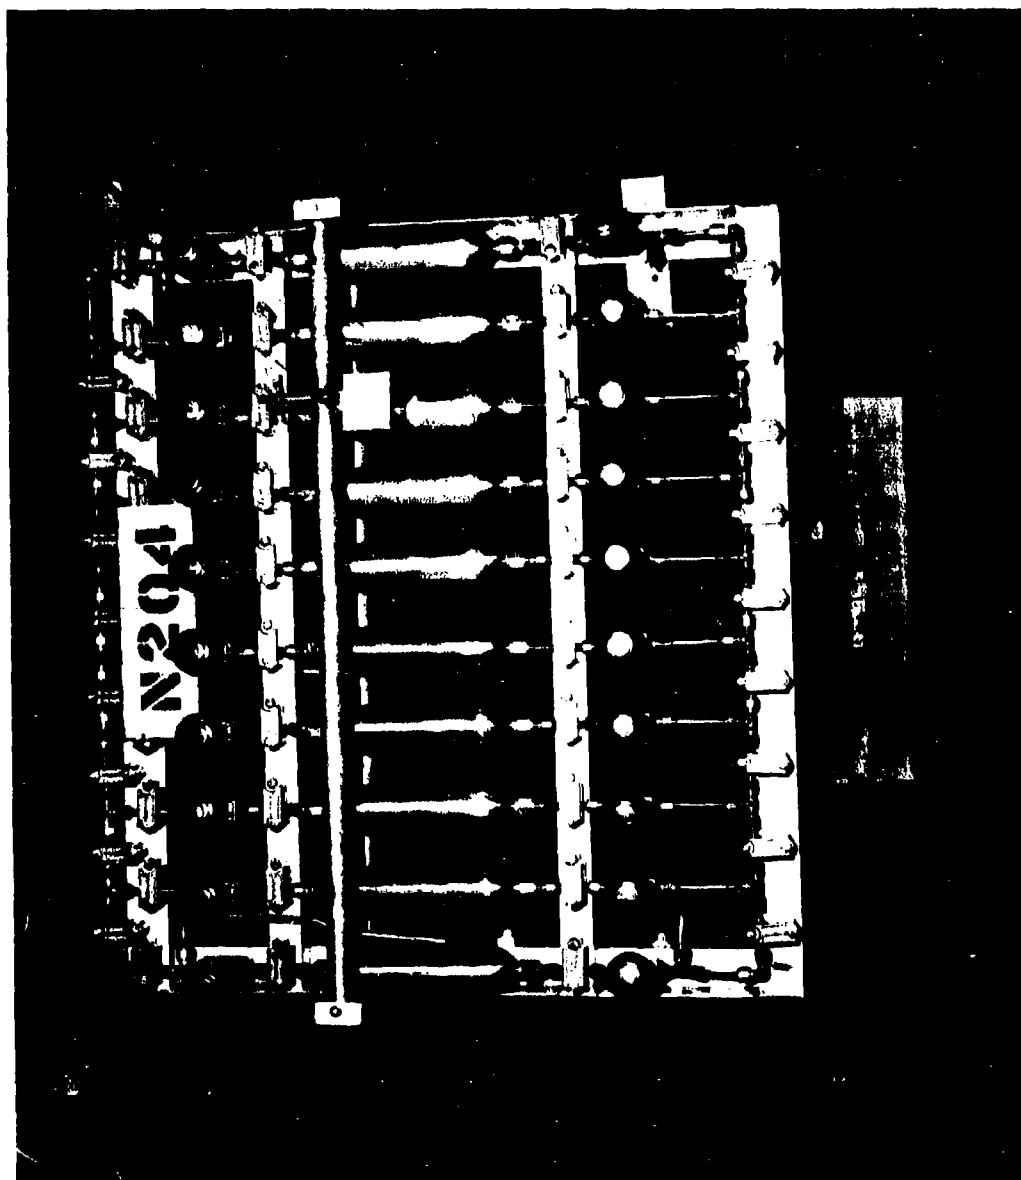
Figure 4. Arde 301 Stainless Steel Cylinders

Part 3 - Arde Cylinders. Small cylindrical containers, developed by Arde, Inc., as high-pressure CO_2 cylinders of AISI 301, cryogenically stretch formed stainless steel, are used to evaluate the storability of this material in both an aged and unaged condition with N_2O_4 and ClF_5 .

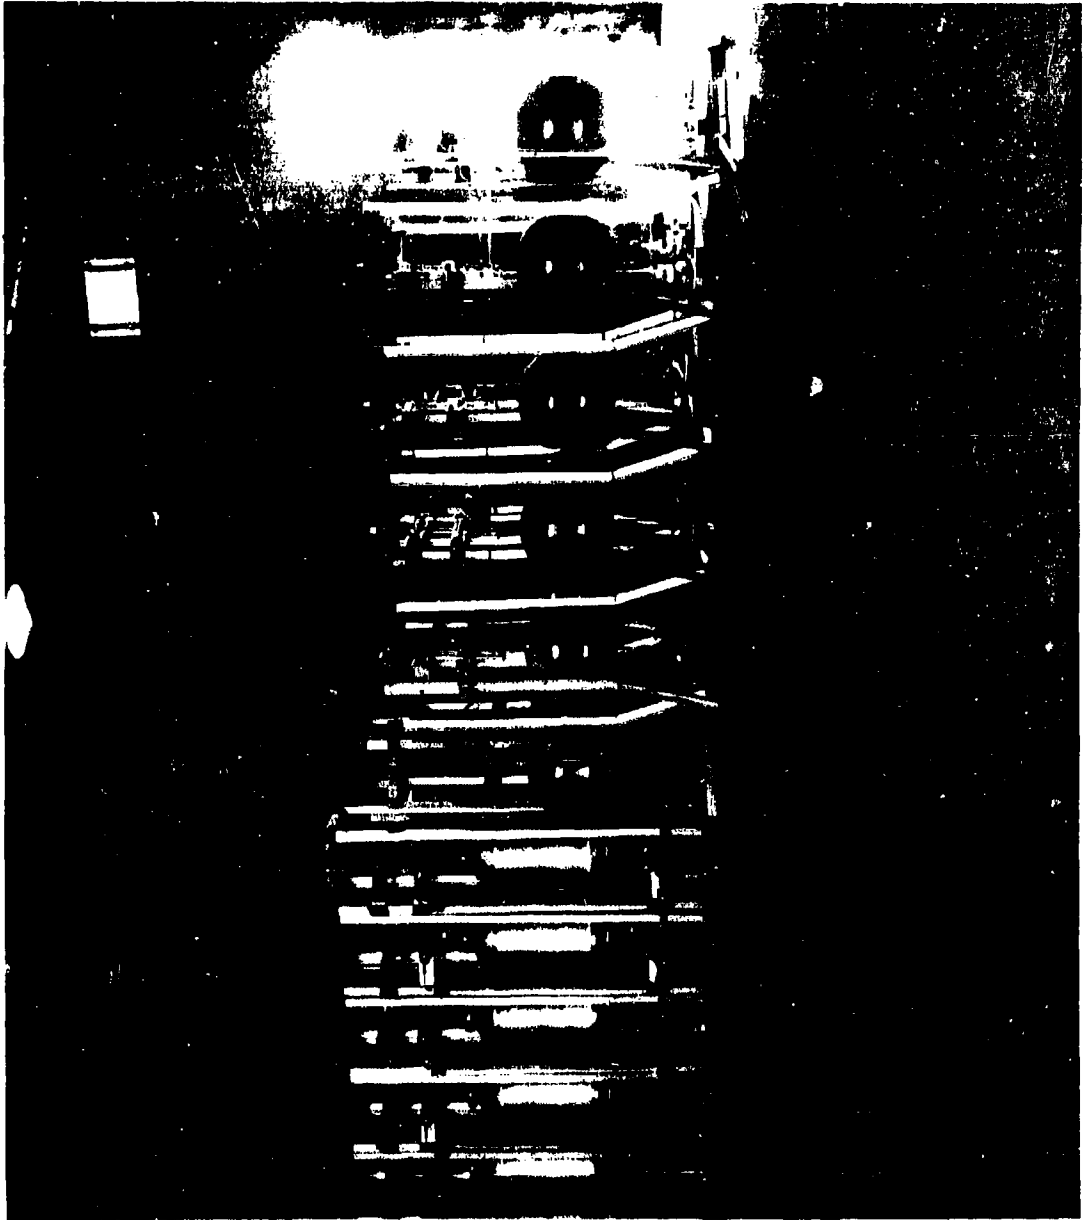
Figure 5 shows these systems located in the Quonset hut. These systems consist of the major components of a propellant feed system which contact propellant during the storage life of the system. Fifteen-gallon tankage is of 2219 T-81 aluminum and AM350 steel. System components consist of pressure switch, explosive valve and burst disk. Fittings are AFRPL mechanical fittings (MIL-F-27417) and TIG welded joints. Since the tankage material and the component materials are of both aluminum and steels, inter-metal transitions are made using both mechanical fittings and solid-state bonded transition joints. Twenty-four systems have been integrated, 12 using aluminum tankage and 12 using steel tankage for storability evaluation with N_2O_4 and ClF_5 .

Figure 5. AFRPL Integrated Systems

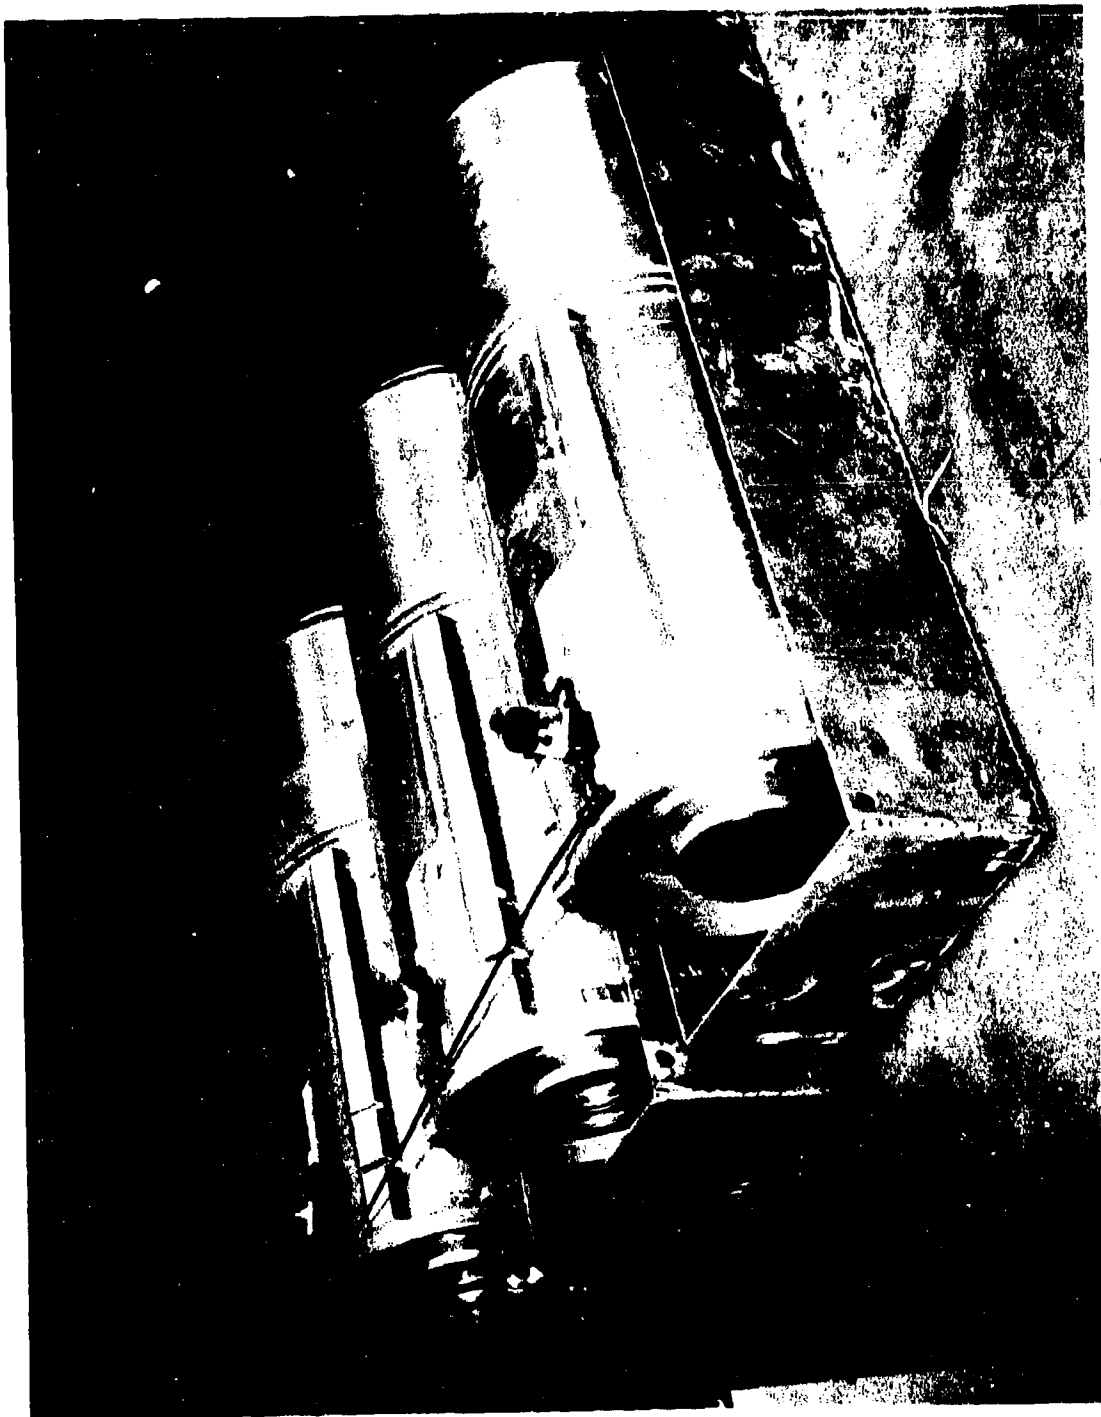
The second type of tankage is a standard Bullpup "B" missile with all ordnance devices omitted. N_2O_4 (MSC-PPD-2A specification (green)) is loaded in both the oxidizer portion (normally IRFNA) and the fuel portions of the tank (normally MAF-2). The tank material is 2014 T-6 aluminum. Three Bullpup "B" missile tanks have been in test since 21 May 1968 with no leakage to date.

Figure 8. Bullpup "B" Missile Tanks

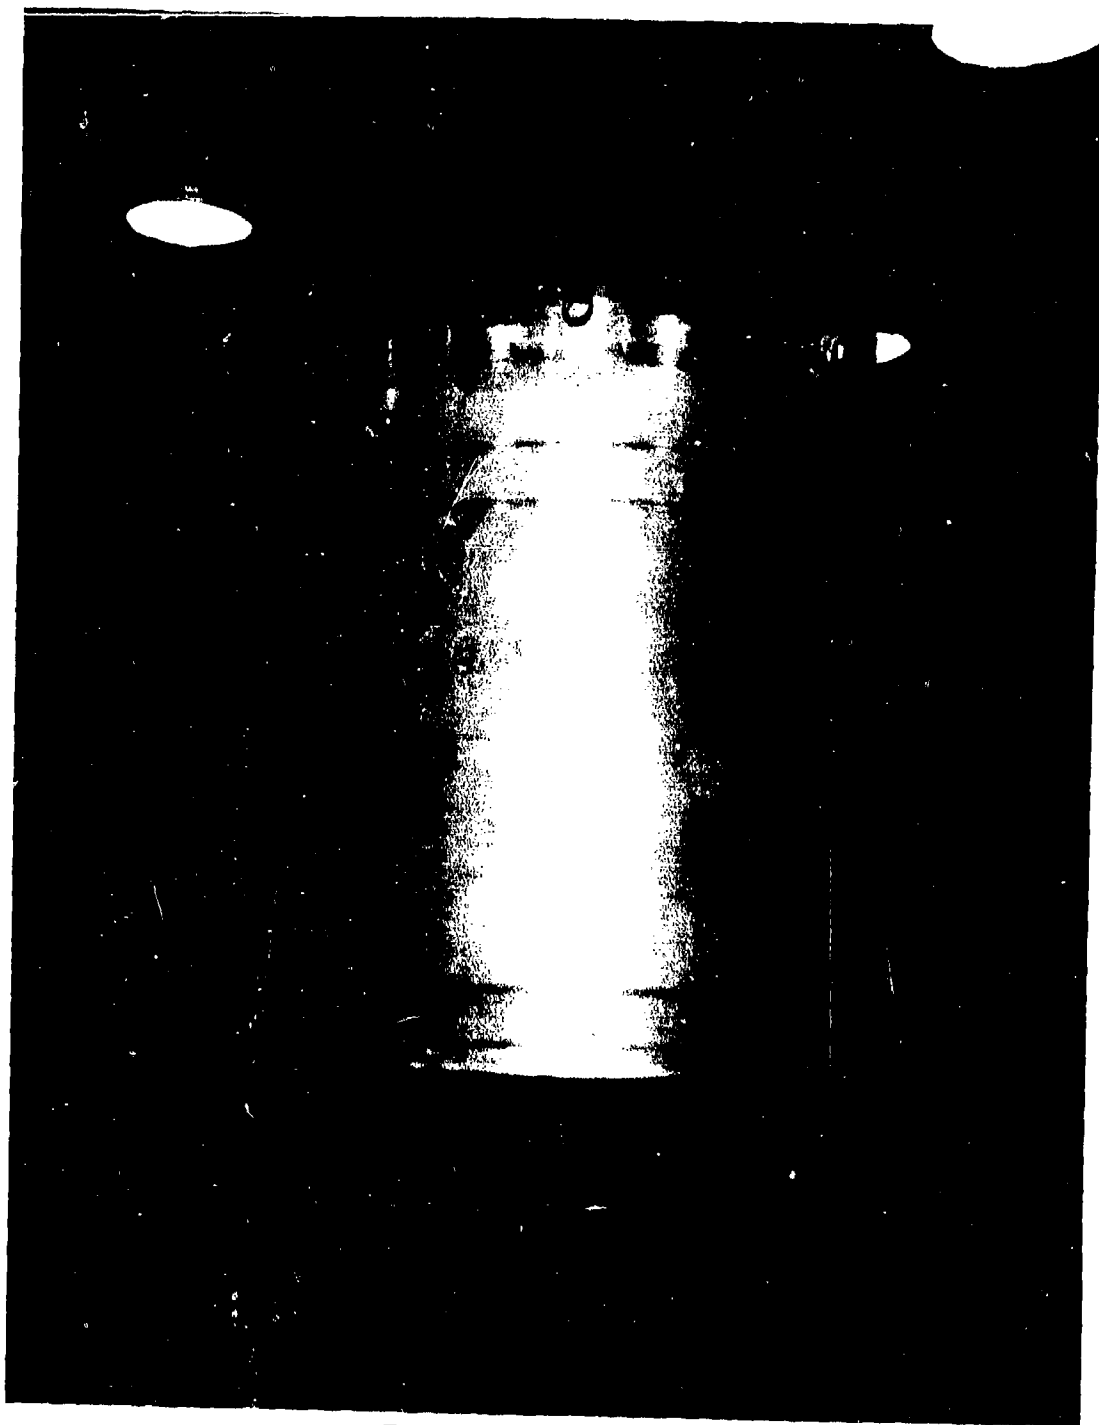
A short-duration storability test of a standard Agena tank was conducted with MSC-PPD-2A specification (green) N_2O_4 (Figure 7). Oxidizer was loaded in both the oxidizer portion of the tank (normally IRFNA) and the fuel portion (normally UDMH). The Agena tankage is 6061 T-6 aluminum with a common dome between the fuel and oxidizer. Testing was conducted for approximately 90 days at 85% relative humidity and 85°F temperature with no leakage occurring.

Figure 9. Agena Tank

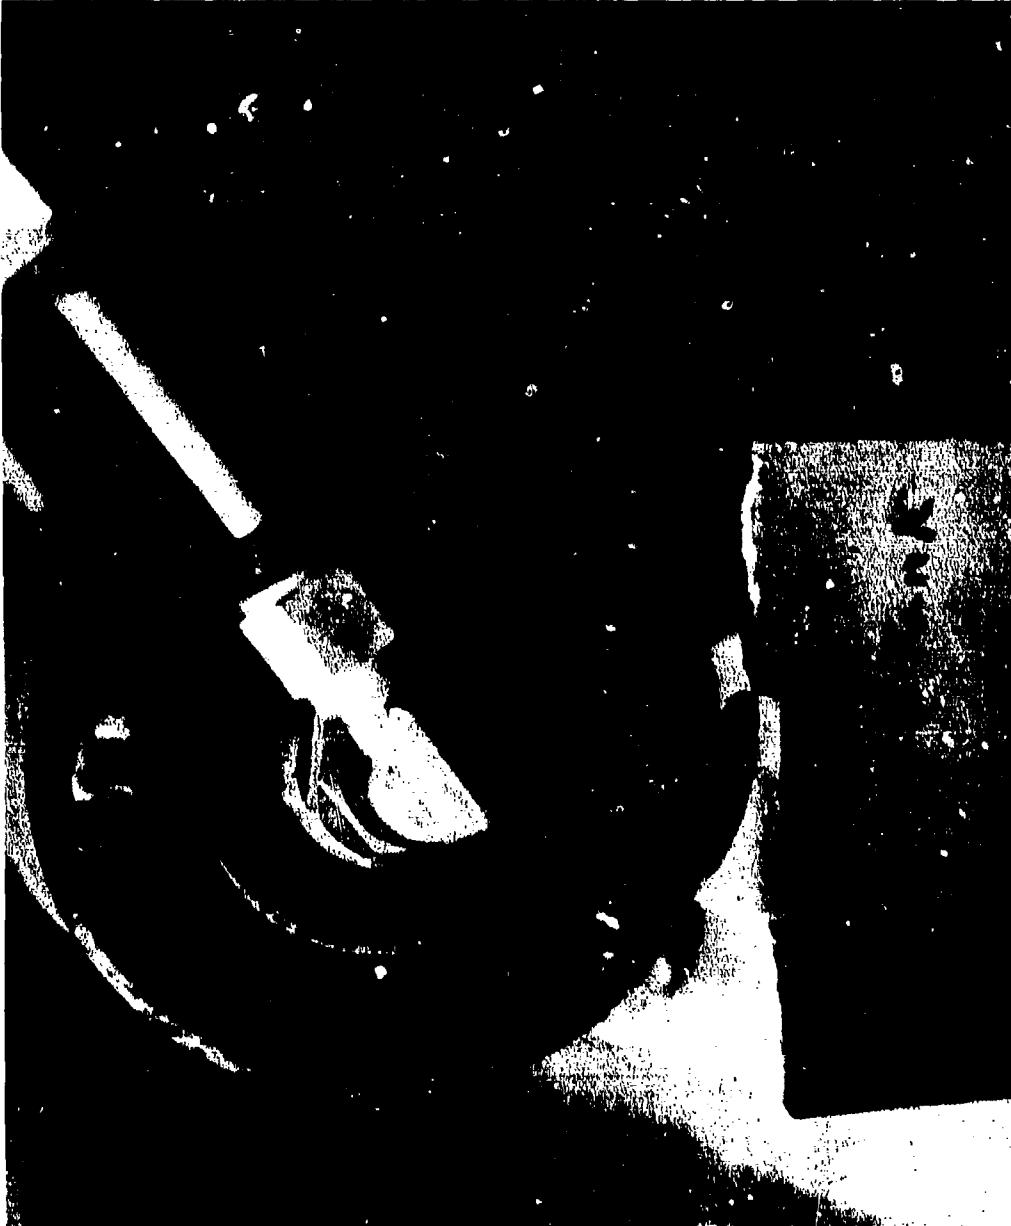
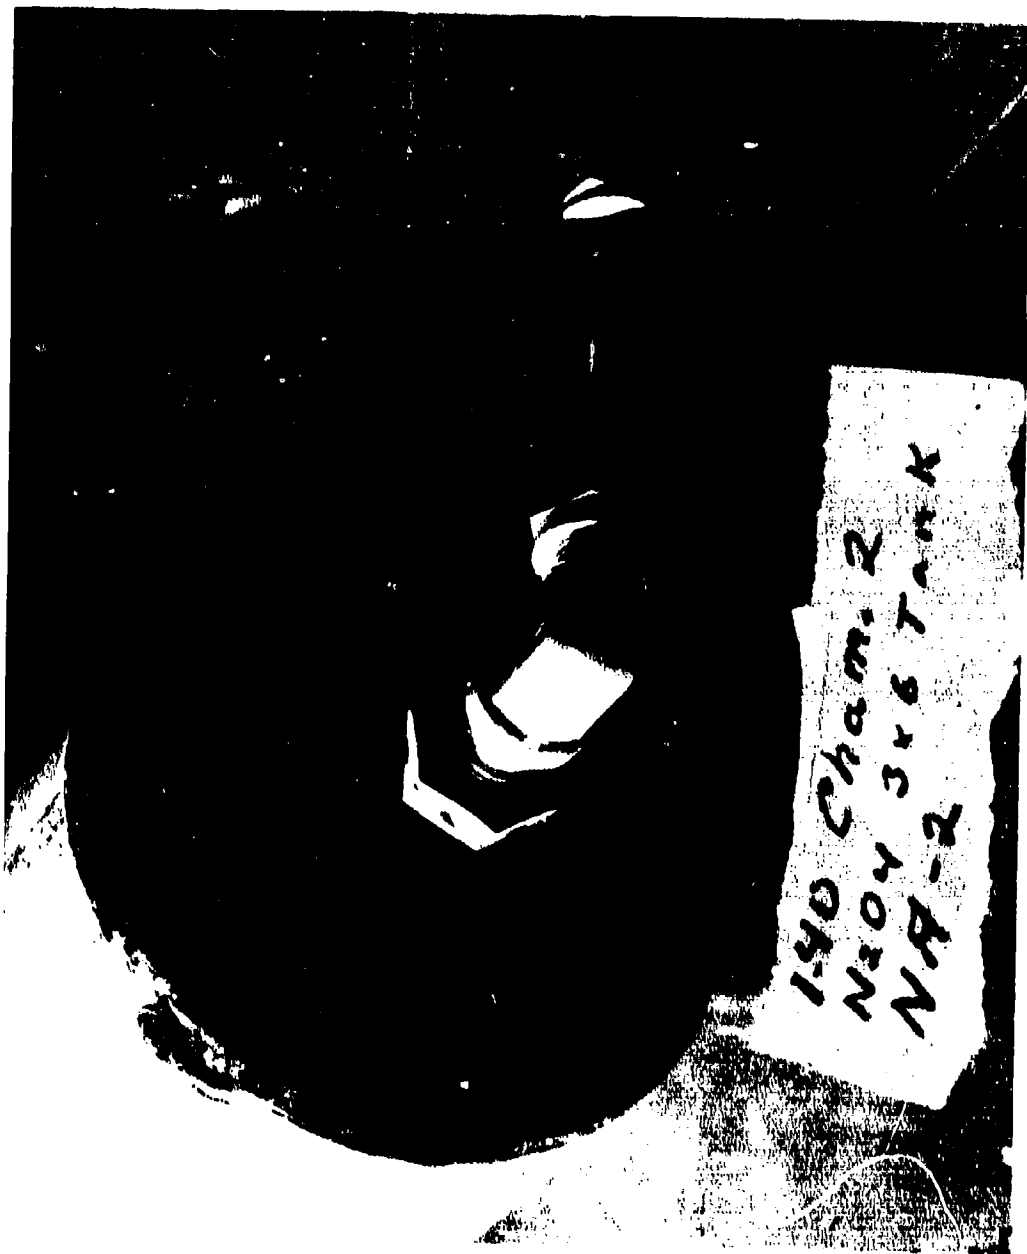
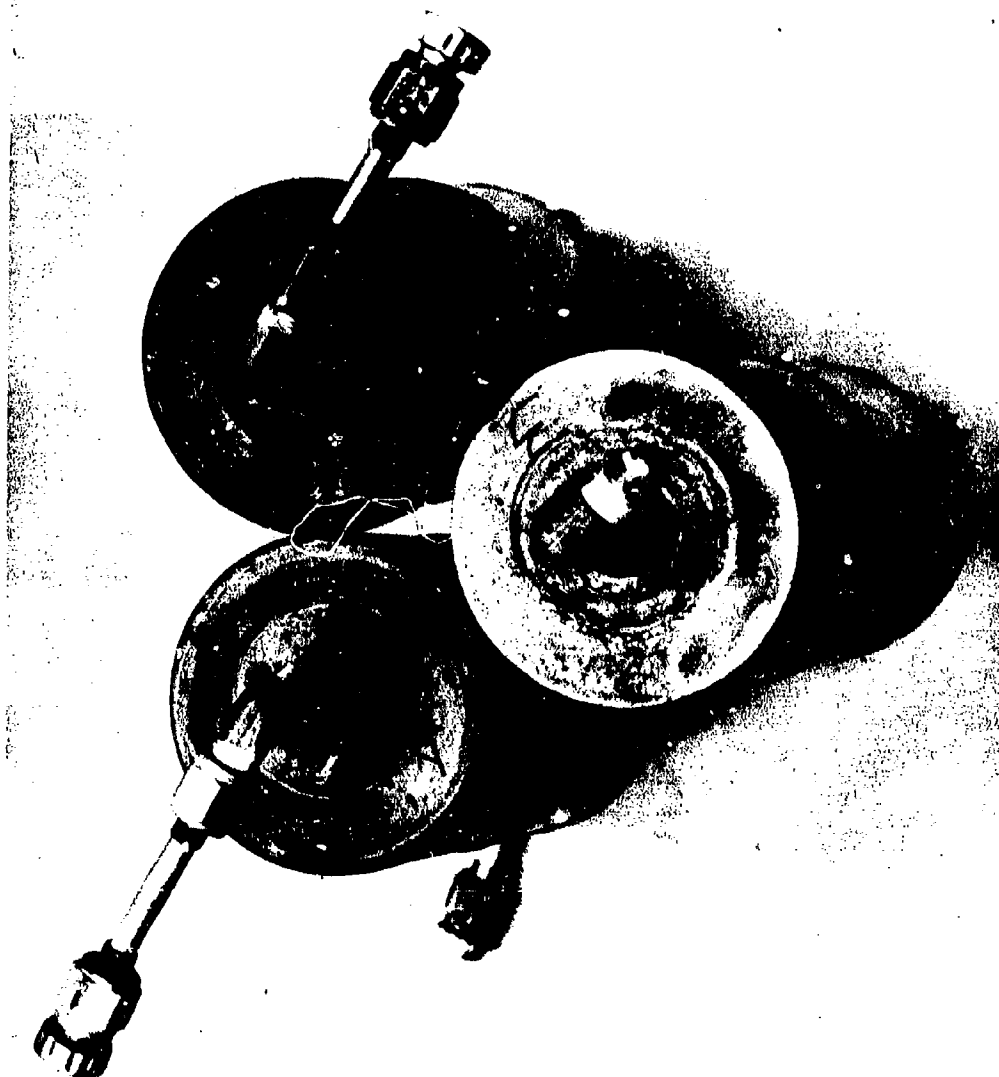
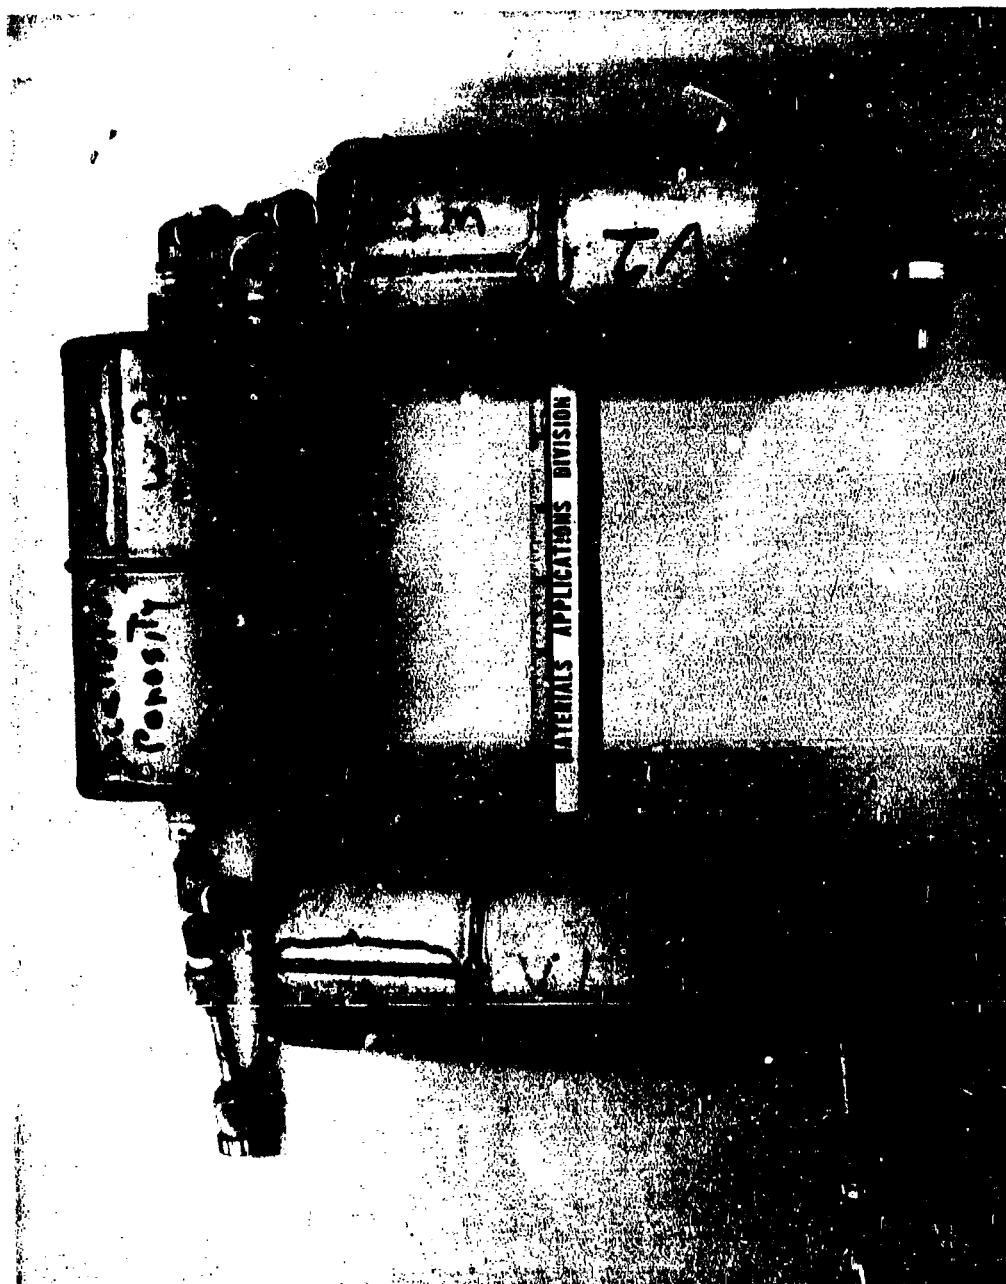
2. Visual examination of the outer surfaces revealed the presence of general corrosive attack in the weld areas, with selective and severe attack in the weld heat affected zones adjacent to the weld bonds. In varying degree, the conditions prevailed on all three containers. Radiography of the weld areas indicated the presence of porosity and variation of weld penetration particularly in the areas in which leaks were observed. It was noted that leakage was very prevalent in the weld overlap areas and at an area which apparently contain a repair weld, see Fig. 2.

Appendix I, Figure 1. Observed Leak in 2014 Aluminum Container

Appendix 1, Figure 2. Observed Leak in 2014 Aluminum Container

Appendix I, Figure 3. Observed Leaks in 2014 Aluminum Containers

Appendix I, Figure 4. Observed Leaks in 2014 Aluminum Containers

2. Selection of a more weldable aluminum alloy, with attendant increase in weight, is suggested as a means of alleviating the tendency toward selective corrosion at the heat affected zones adjacent to weldments.

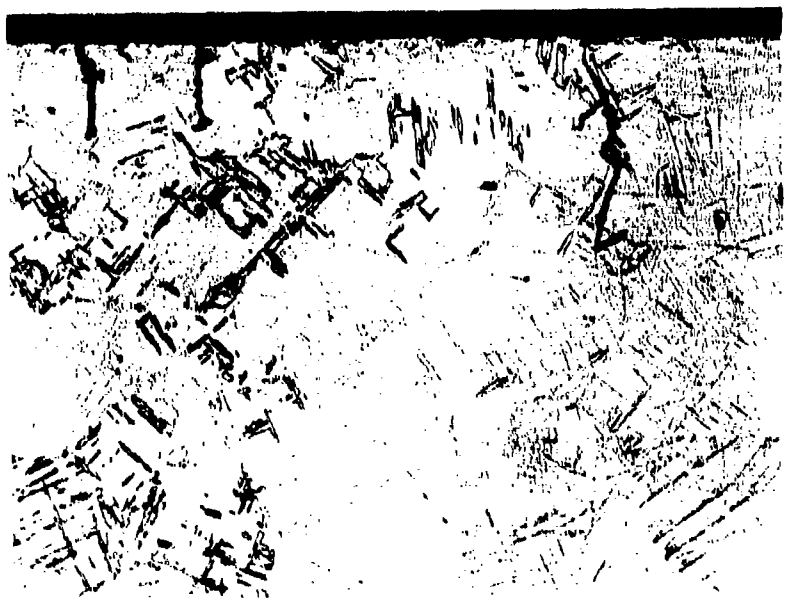
C-2749

The morphology of the cracks observed is typical of that normally associated with N_2O_4 stress corrosion cracking of the titanium-6Al-4V alloy. There seems little doubt that the failure of the tank was anything other than stress corrosion cracking. While little or no differences in susceptibility to stress corrosion cracking in N_2O_4 has been observed for welds versus parent material, the fact that the cracking in this case is associated with the weld is not expected. For example, pressurizing the tank to 1000 psig results in a hoop stress of only 13.3 KSI. This is far below the threshold stress of about 40 KSI which has been found to initiate cracking of titanium in N_2O_4 . It is interesting to note that the crack occurred at a weld overlap or severed area. Such a condition would be expected to give rise to highly localized stresses which coupled with the applied load of 13.3 KSI are sufficient magnitude to initiate and propagate a stress corrosion crack. The fact that four other titanium tanks (one Ti-6Al-4V, three Ti-5Al-2.5Sn) have failed in your N_2O_4 storage studies at a double pass weld, to junction weld and/or weld repair is further evidence that such conditions endure high stresses necessary for cracking in N_2O_4 . It is doubtful that any failures would have occurred at least in the short exposure time if the welds had been of a different configuration.

Appendix II. Figure 3. Small Cracks Toward the End of the Heat-Affected Zone

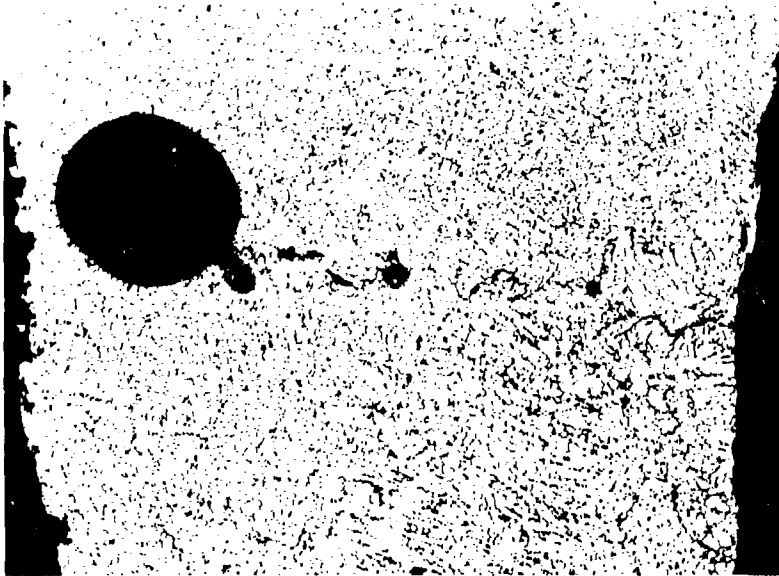
The major leak point at the tee junction of the weld was sectioned. Numerous large gas voids with an interdendritic crack network running from hole to hole was found. This is shown in Figure 6. There is no doubt that the weld itself played a major role in the failure at this point. The number and size of the gas voids in the weld is reason enough to conclude that the weld was substantially weakened at this point. A sound weld of good quality would not be expected to suffer corrosion in the N_2O_4 .

Appendix II, Figure 6. The (a) Unetched and (b) Etched Cross Section of the Crack Through the Weld Tee Junction

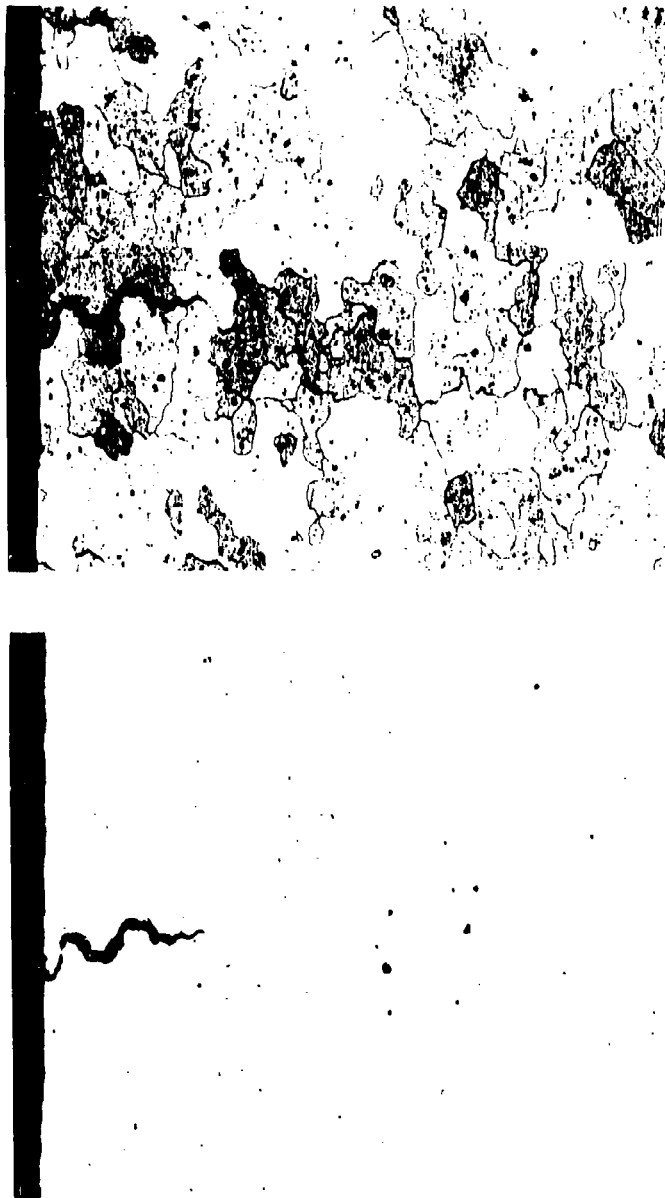
A number of small white spots were observed adjacent to the weld in the vicinity of the leak at the tee. Similar spots were also found either in or near the entire area of the top circumferential weld. The center of each spot contains a small fissure oriented perpendicular to the direction of major stress on the tank. This consistency of orientation perpendicular to the major stresses suggests a stress enhanced failure mechanism.

Figure 7 is a cross sectional view of the fissure in the largest of the white spots where the second leak was marked.

This type of intergranular corrosion is a common observation on aluminum alloys. An applied stress enhances such attack and this would explain the unidirectionality observed. The initial breakdown of the normally passive N_2O_4 /aluminum system at these points is believed to have been caused by surface contamination.

Appendix L. Figure 7. The (a) Unetched and (b) Etched Cross Section Through the Largest of the White Spots Containing Intergranular Fissures

Contamination could have been present from many sources such as water condensate during shipping or cleaning fluid residue. The combined action of some contaminant and the N_2O_4 environment is the probably cause of the accelerated attack.
